Mining in extreme squeezing conditions at the Henty mine

B. Roache, Mining One Consultants Pty Ltd, Australia

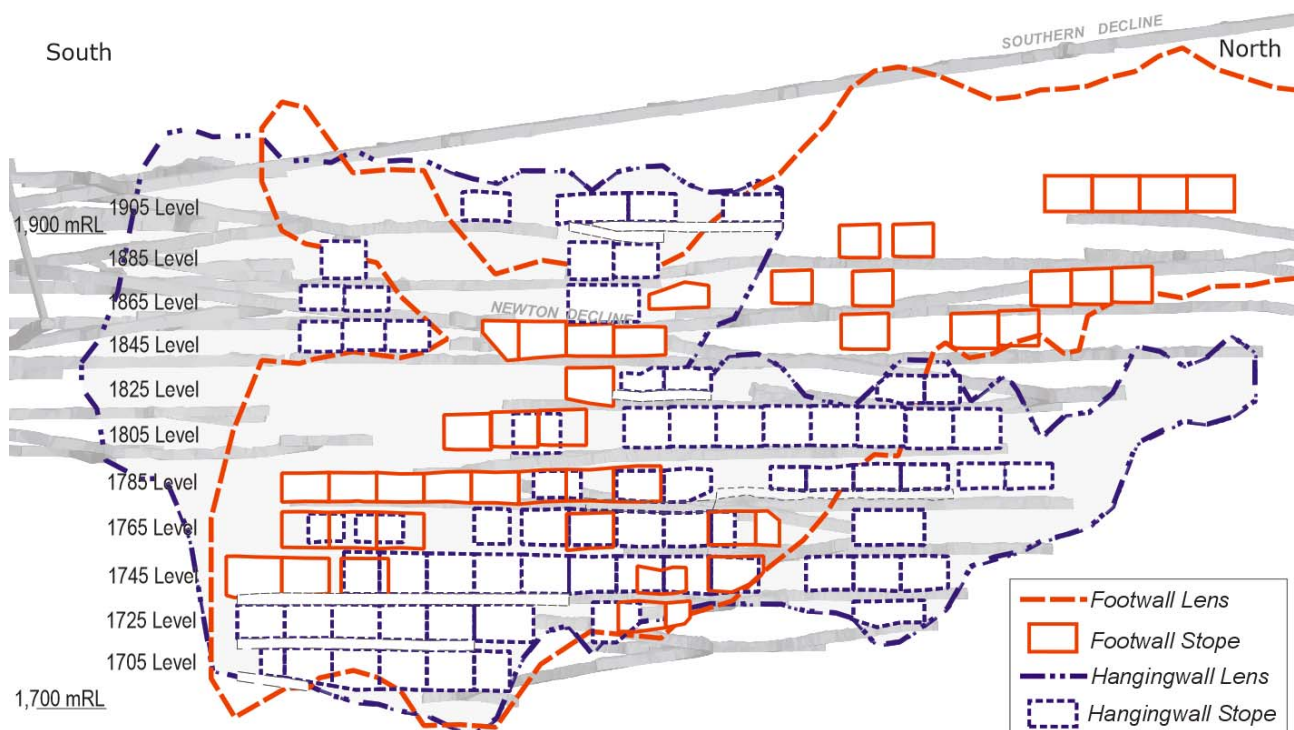
Figure 2 a) Henty mine longitudinal section b) Newton zone longitudinal section

The Newton orebody is located between 650m and 800m below surface level with an approximate vertical dip and striking north-south. There are two parallel ore lenses, each about 3.5m width, with parts of each ore lens sub-economic for open stoping. The distance between the two ore lenses varies between about 5m and 8m, refer to Newton zone longitudinal section, Figure 2.

a) Henty Mine Longitudinal Section

b) Newton Zone Longitudinal Section

Mining development was based on a 20m level spacing and ore drive development was initially 3.6m wide, 4m high arched profile. The development was later changed to 4m width when the extent of squeezing conditions became apparent with ongoing development experience. The Newton Zone stope strike lengths were generally around 17m and stopes filled with rock fill. Narrow rib pillars were left behind to contain the rock fill.

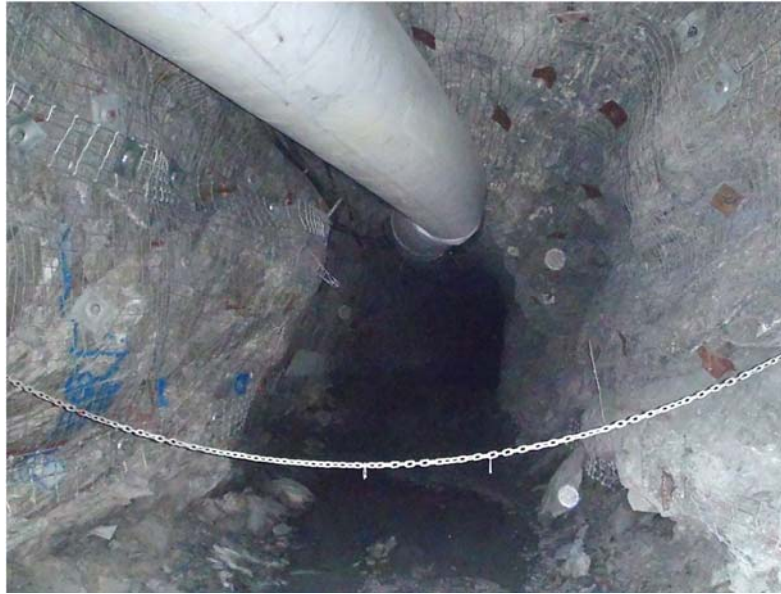
Figure 4 Typical squeezing drive in the Newton Zone

Visual observation of drive performance commonly included shearing of foliation in the drive side walls leading to offsets and 'guillotining' of the rock bolts and significant drive wall closure at up to 20 mm/day but more commonly between 2 to 4 mm/day. The roof and floor bulked and heaved respectively, refer to Figure 4.

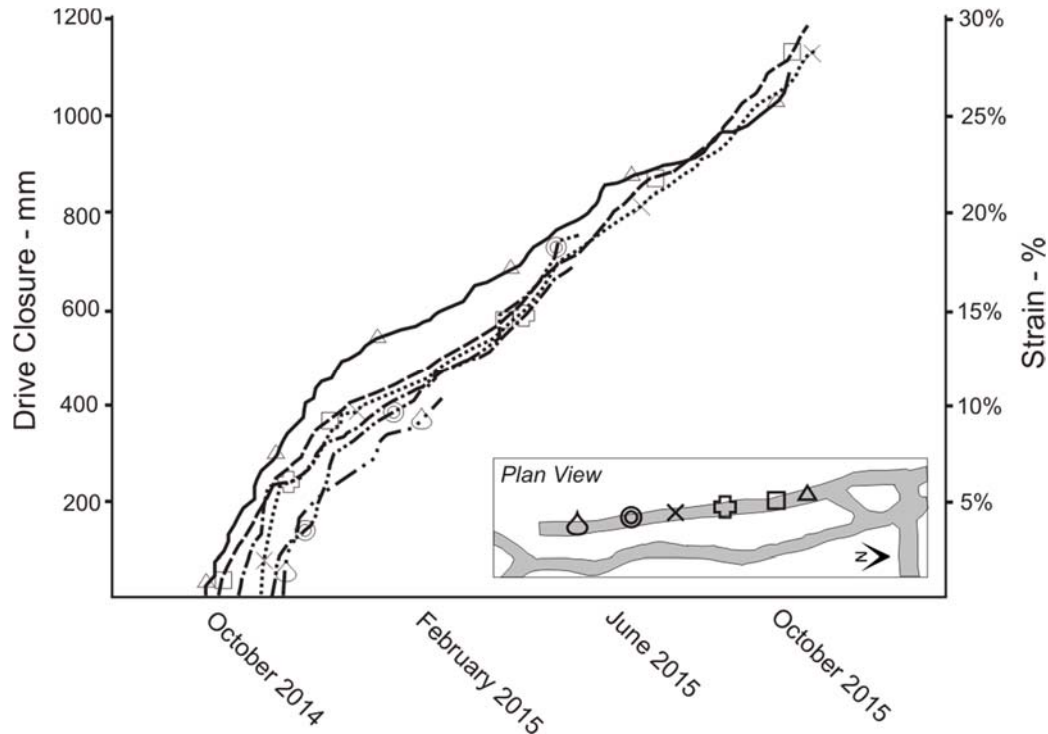
Figure 5 Wall closure monitoring in the NW1765HWS

The drive closure monitoring data shown in Figure 5 describes the wall movement over time in the NW1765HWN, an ore drive positioned parallel to foliation and with a footwall drive located in close proximity to the east. This wall movement is typical of ore drives within the Newton zone. Wall strains of over 30% were experienced with only minor regression in the wall closure rate. Small adjustments have been made to smooth steps in the monitoring data, as stripping did take place along the entire length of the ore drive causing unavoidable loss of monitoring points and short term restriction of access to the drive preventing continuous drive closure survey.

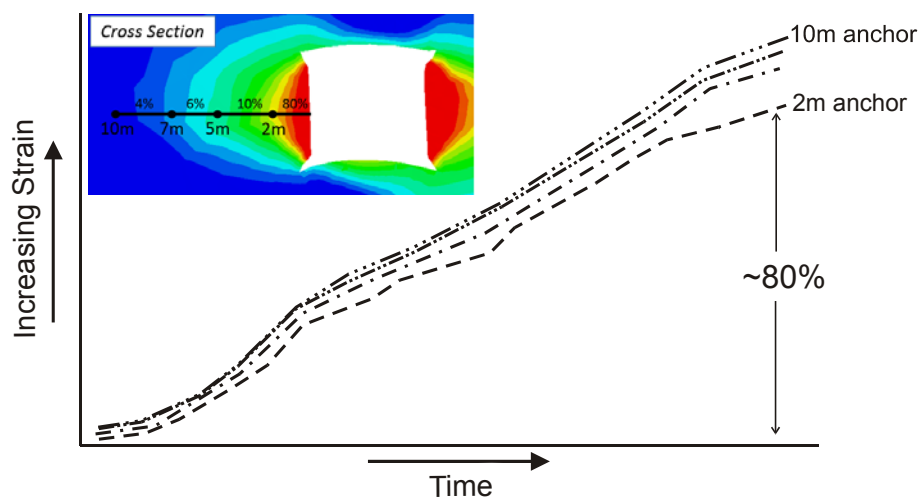
Figure 6 Typical sidewall behaviour

Monitoring data from within the walls and roof of the ore drives demonstrated consistent patterns. The first 2m of wall material showed about 80% of the total side wall strain, as shown within Figure 6. Deeper within each wall the yield zone continues but at reducing strain amounts. Between 2m and 5m depth about 10% of total strain, between 5m and 7m about 6% of total strain and between 7m and 10m about 4% of total strain.

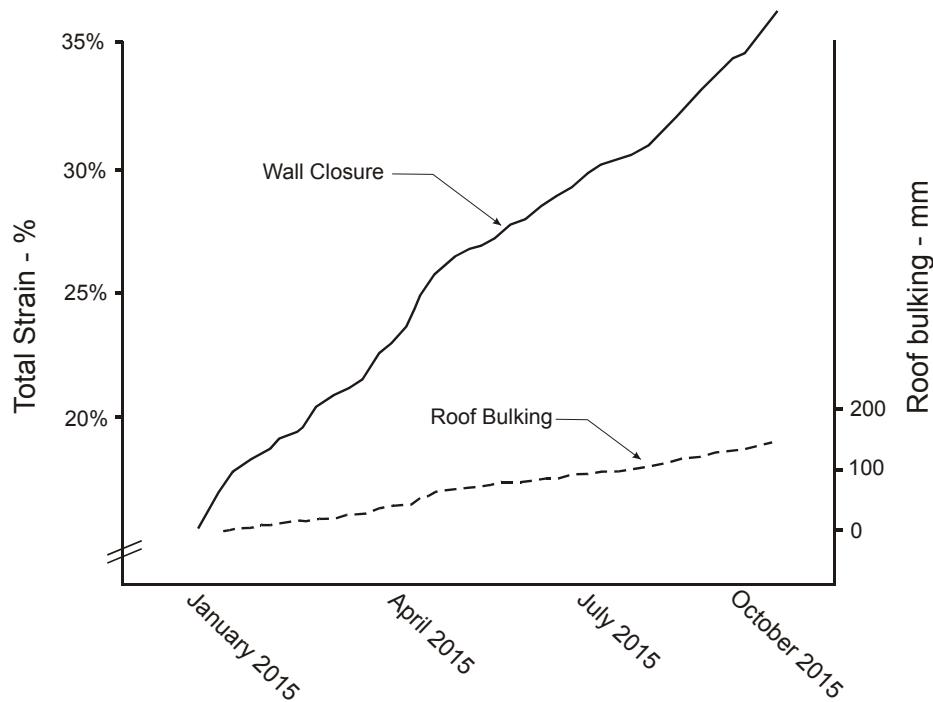
Figure 7 The relationship between wall closure and roof bulking

The ore drive roofs performed consistently and predictably, despite progressively bulking over time. The majority of ore drive roof strain occurred between 3m and 6m depth, beyond the depth of the 2.4m long roof bolts. No increase in the rate of roof bulking relative to drive closure rate was noted, even at drive closure strains beyond 20%.

Induced stress in the roof clamped the roof material in place, until roof bulking caused eventual breakup of up to 1m of roof material at the excavation boundary. This break up of material at the roof boundary occurred only when drive closure strain had well exceeded 20%. This highlights how time-dependant rock mass deterioration must be understood during ground support design and verified during mining.

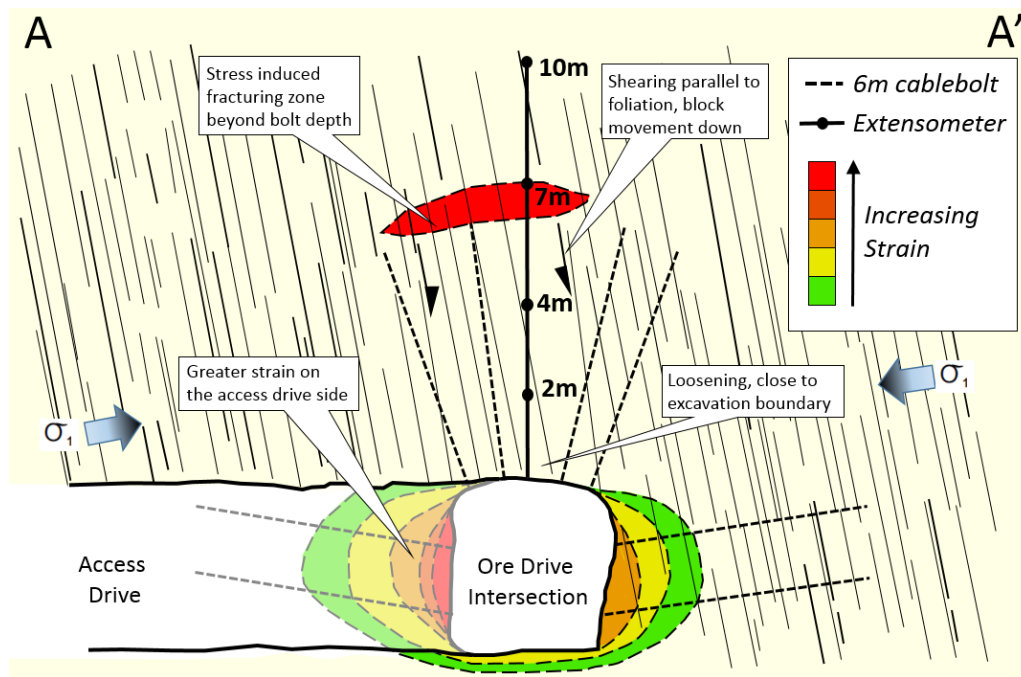
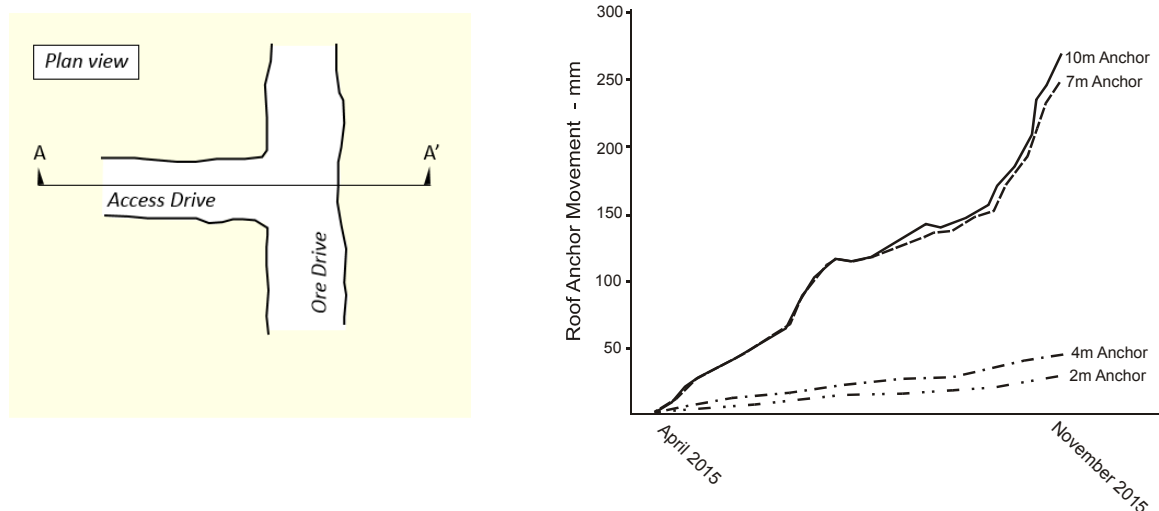
Figure 8 a), b) & c) Monitored observations of extreme strain around intersections

Monitoring of intersection roof bulking in Newton Zone suggests that the majority of roof movement was occurring beyond the cablebolt embedment length, which were 6m long in most instances. Cablebolting was successful in reinforcing the 6m above the intersection and holding the material together while the ongoing movement of the walls allowed the “6m reinforced block” to move into the intersection. This deeper roof movement may also be related to shearing on foliation planes and further work modelling this mechanism is required to validate these observations. Extensometers were essential in the daily management of the intersections, refer to Figure 8.

a) Observations of extreme strain around ore drive intersections – cross section

b) Plan view of cross section location c) Extensometer monitoring of the intersection roof (NW1765 Link)

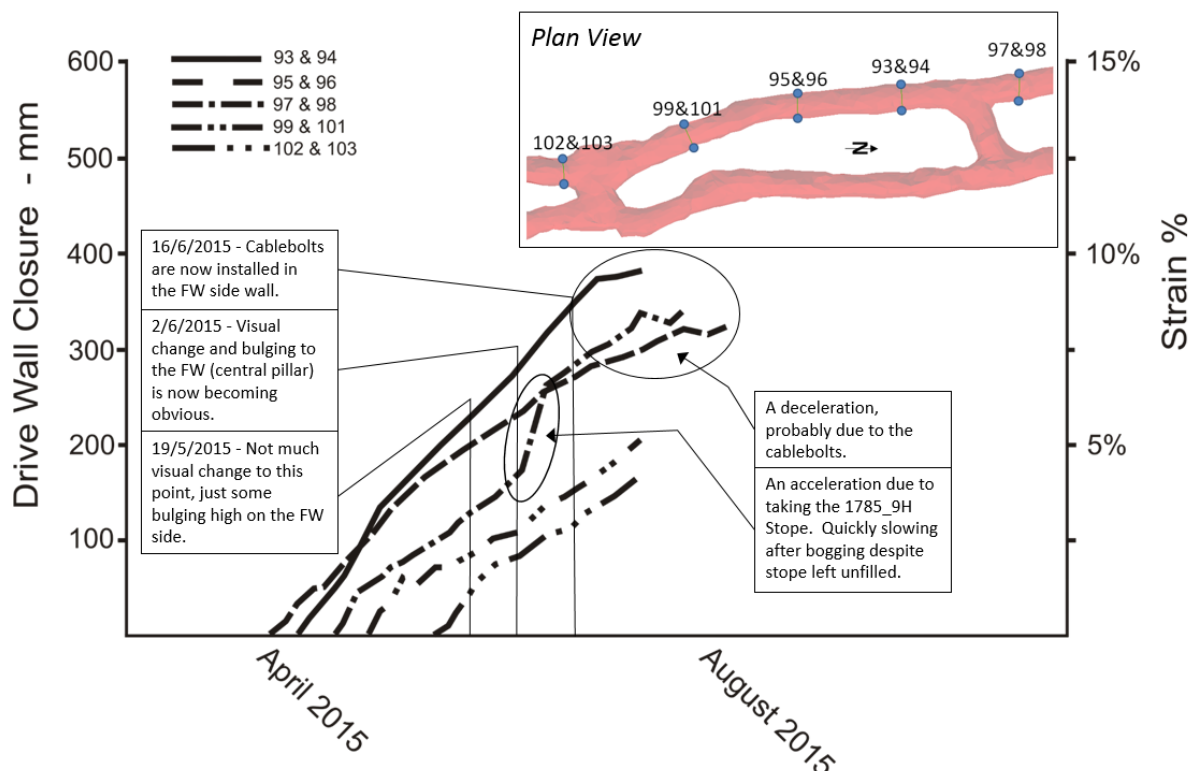
Figure 9 Closure monitoring data with observations of performance at the 1785HWS

An example of manageable strain within the Newton Zone 1785HWS ore drive, developed parallel to foliation is shown in Figure 9. This drive was one of the last developed in the Newton Zone and was better planned, supported and reinforced to avoid stripping of the drive prior to stoping commencing. The drive experienced strain of up to 10%. The visual change over time of what 10% strain actually looks like is shown in Figure 10 (this corresponds with up to about 400 mm of drive closure at this location). It should also be acknowledged that drives with identical amounts of strain will perform differently in terms of stability.

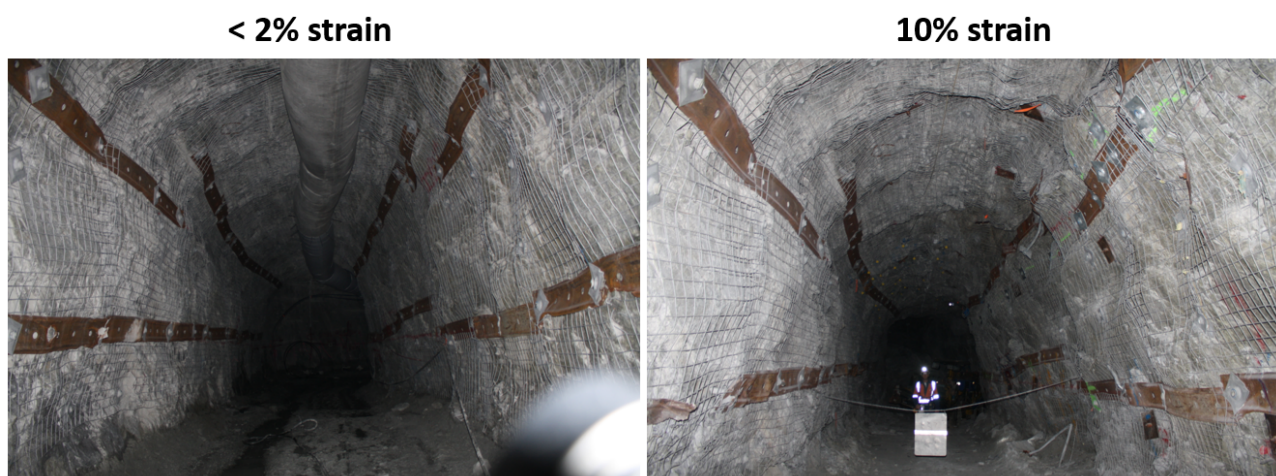
Figure 10 Photographs of 1785HWS. Visual indications of drive change are relatively minor, despite the 10% strain being associated with about 400 mm of closure

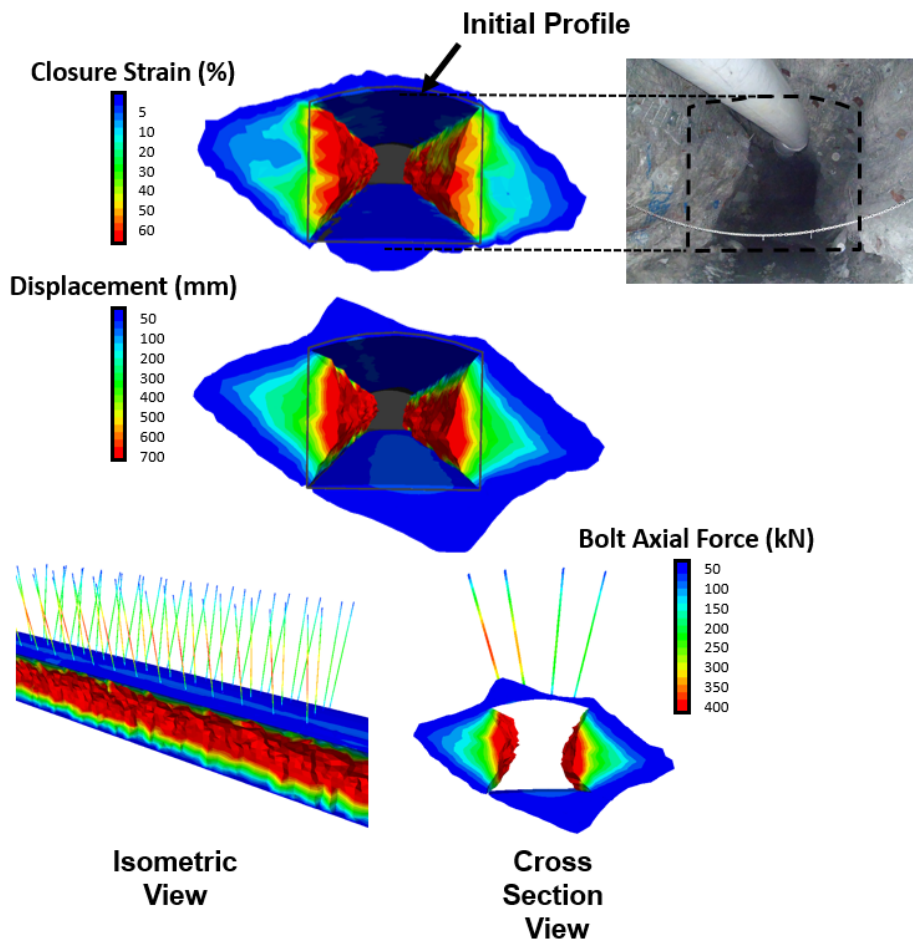
Figure 11 Newton Zone IUCM model – ore drive and stope brow bolt performance

Considering the complexities involved with the ground conditions at the Newton zone, conventional ground support design methods and numerical modelling techniques are not able to capture the correct failure mechanism. To assist in predicting and understanding of appropriate ground support strategies, a 3D numerical model was developed for the Newton Zone utilising the IUCM method described by Vakili et al (2014). The model accounts for critical factors controlling the failure mechanism in highly stressed and highly anisotropic ground conditions, such as those at Henty Mine. The numerical modelling complimented the ground support design techniques commonly used at Henty Mine that consider the rock mass, rock structures and engineering experience.

This modelling methodology has provided reliable forecast of rock mass behaviour at number of other mine sites with similar ground conditions to Henty Mine, hence the decision to use this approach. The IUCM accounts for mechanisms, such as the transition from brittle to ductile response at various levels of confinement, dilatational response, strength anisotropy, and stiffness softening. As shown in Figure 11, this modelling method was able to forecast the rock mass response to mining with a high level of precision using the realistic input parameters obtained from lab testing and field investigations. A good correlation between monitoring data and model outputs was achieved. This model was used for optimisation of ground support design, primarily at stope brow positions and proved to provide a reliable and cost effective design method.

Ground support design for extreme squeezing conditions is a complex and difficult task. A 3D numerical model using the IUCM method assisted by predicting and understanding appropriate ground support strategies. A good correlation between monitoring data and model outputs was demonstrated to provide reliable forecast of rock mass behaviour.
